ARBOR SERVICES REPORT

Re: City of Edgewater – Historic Tree Assessment
2813 Victory Palm Drive

Project No. : ZC 15197

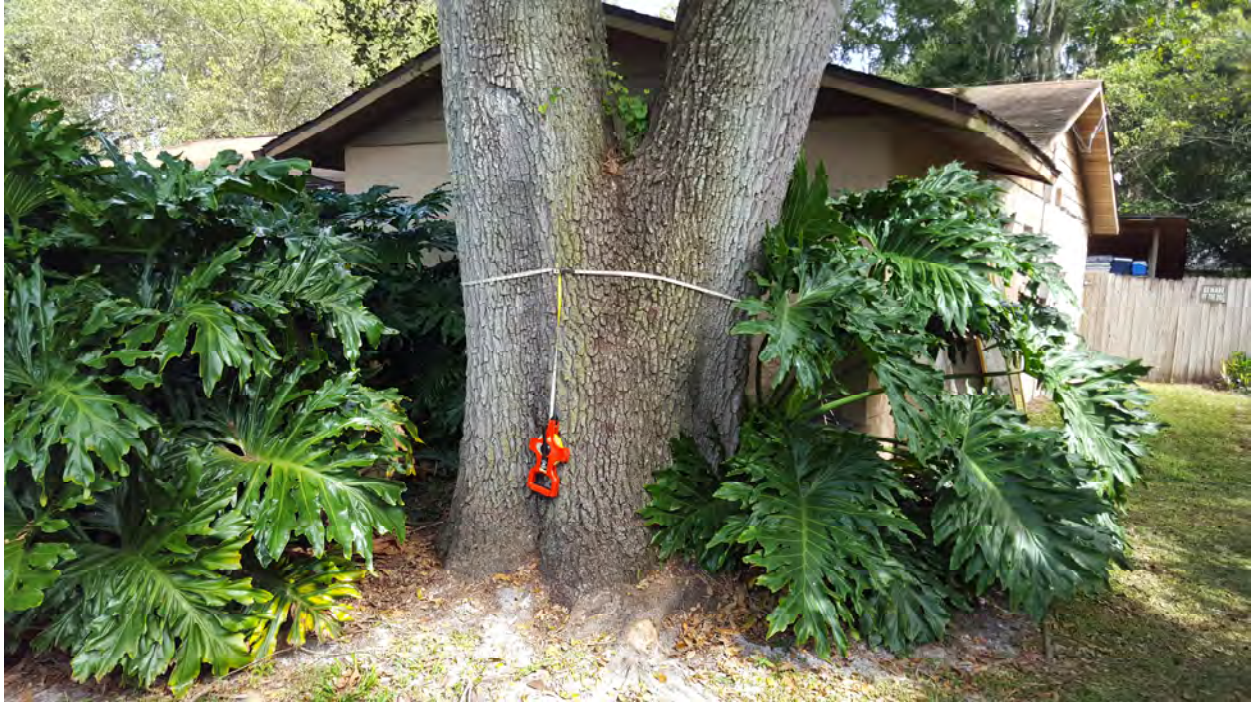
The property was visited on October 21, 2015. **The subject tree was confirmed to be a live oak (*Quercus virginiana*) with a DBH of 47.43” and therefore classified as a Historic Tree.** The identification was easily made as the tree exhibits characteristic live oak habits and morphology. The leaves are leathery in texture, dark green above and pale green/ grey tomentose below.

Figure 1 : 47.43” DBH Trunk of subject tree showing is bifurcated with bark ridge

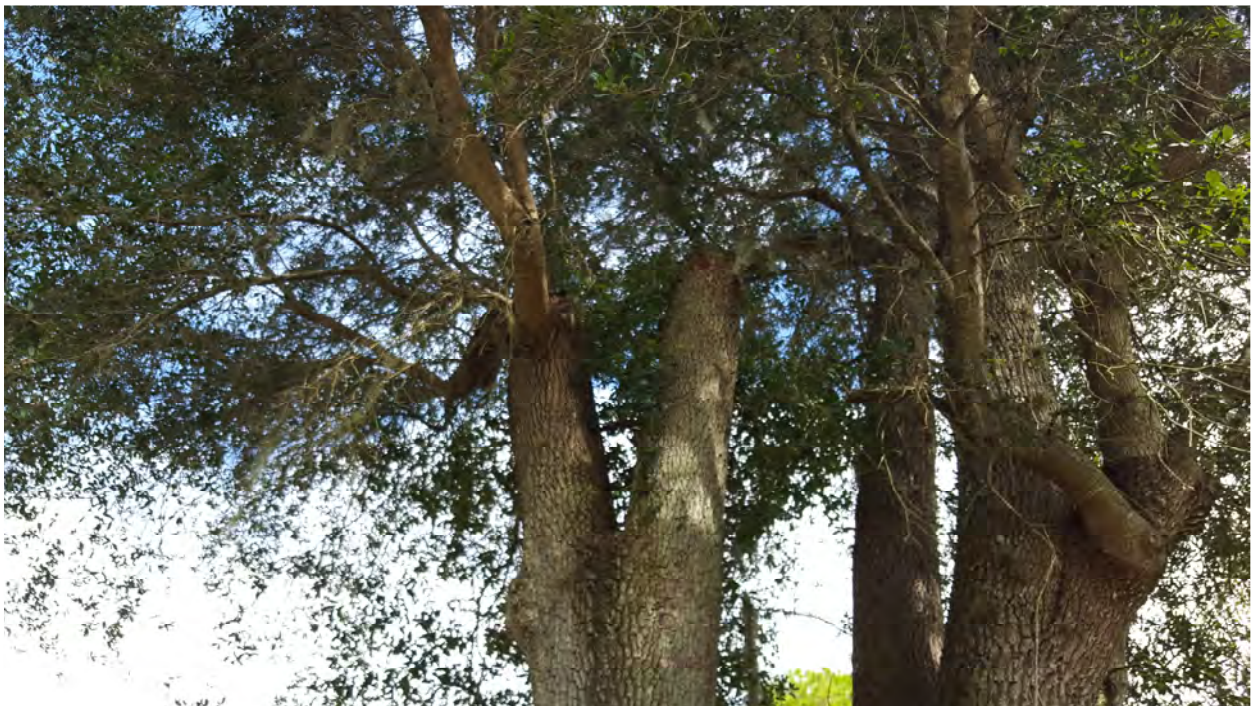
The subject tree is located near the dwelling on the southwest corner and overhangs a portion of the residence. The subject tree appeared to be in fair health. The trunk is bifurcated just above breast height and both resulting codominant stems are also bifurcated, all displaying distinct bark ridges that appear to show weakness in the overall stability of the tree. In addition, storm damage and poor trimming are apparent and the resulting lateral branching is unfavorable.

Figure 2 : Codominant stems of subject tree showing bifurcation with bark ridges. Storm damage and poor trimming are apparent and the resulting lateral branching is unfavorable

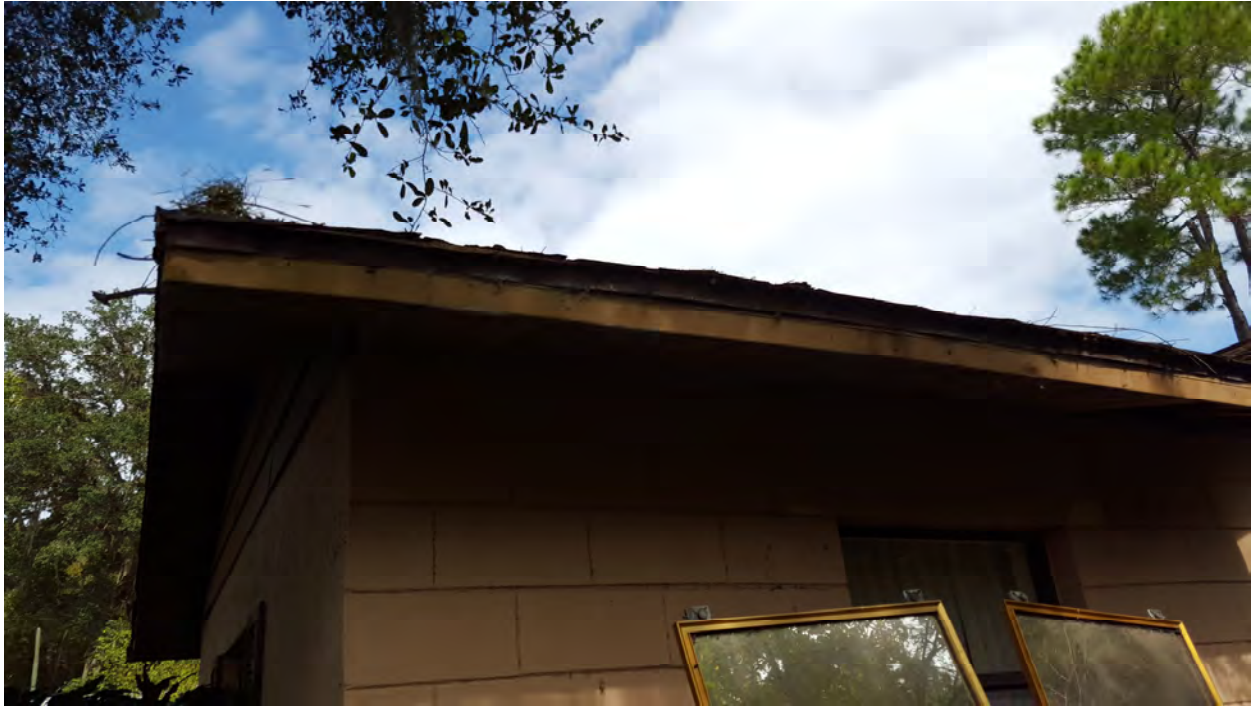
Figure 3 : Subject residential property showing storm damage resulting from falling limb.

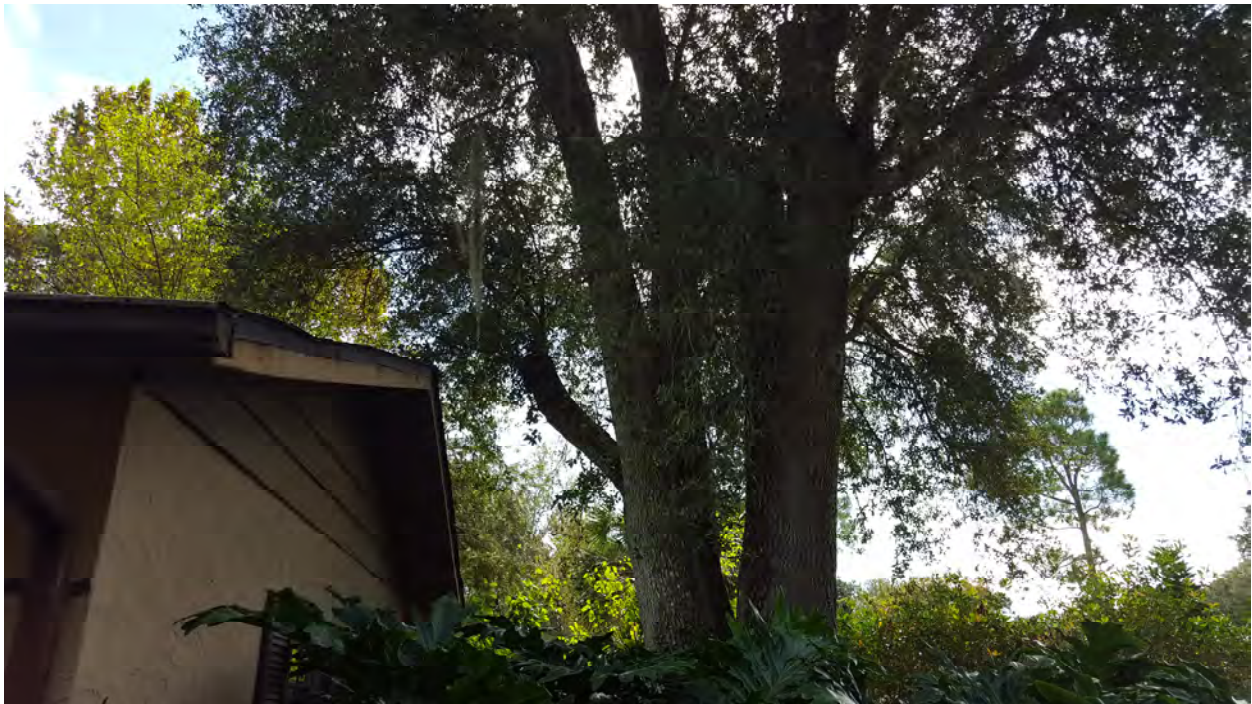
Figure 4 : Trunk of subject tree observed has poorly trimmed codominant stem.

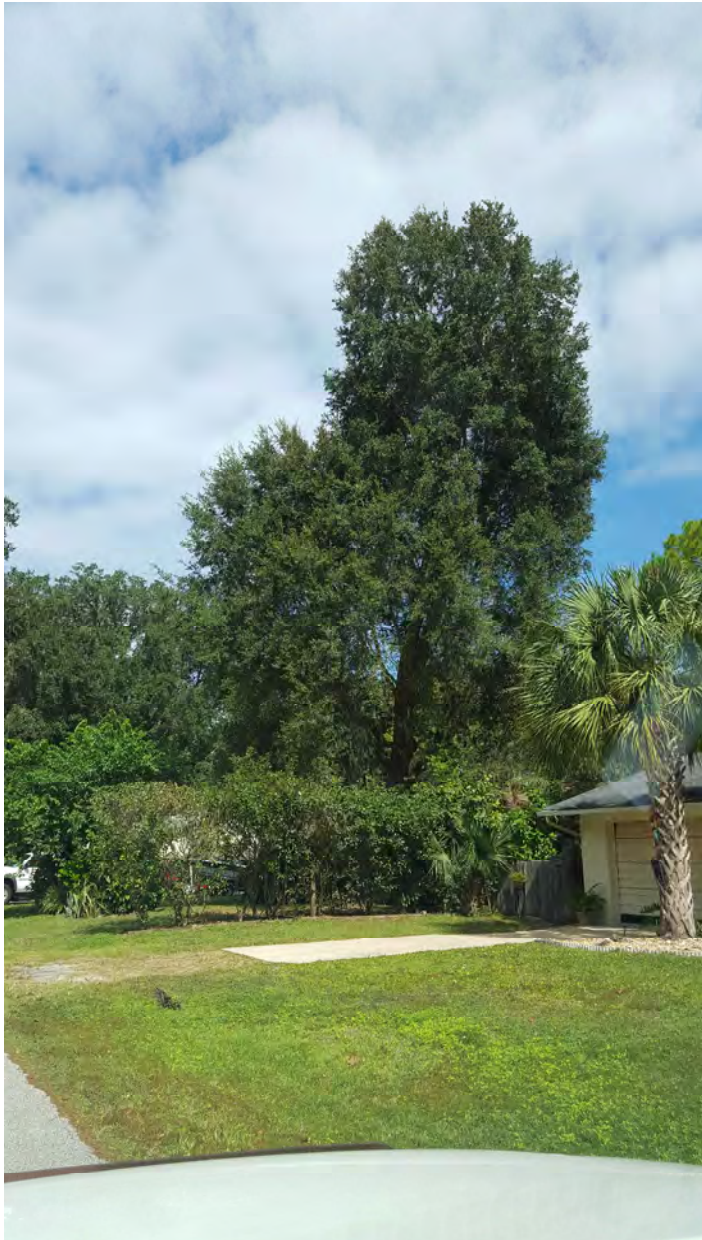
Figure 5 : Overview of tree showing has poor lateral branching.
