**Arbor Report**  
March 24, 2026

Re: Tree Health and Risk Assessment and mitigation for one (1) live oak (*Quercus virginiana*).

Services were retained to assess the health and risk for one (1) tree located at the **Merritts Boat & Engine Works** project, 200 W Park Avenue, Edgewater Fl., and propose mitigation options for removal. (Figure 1).

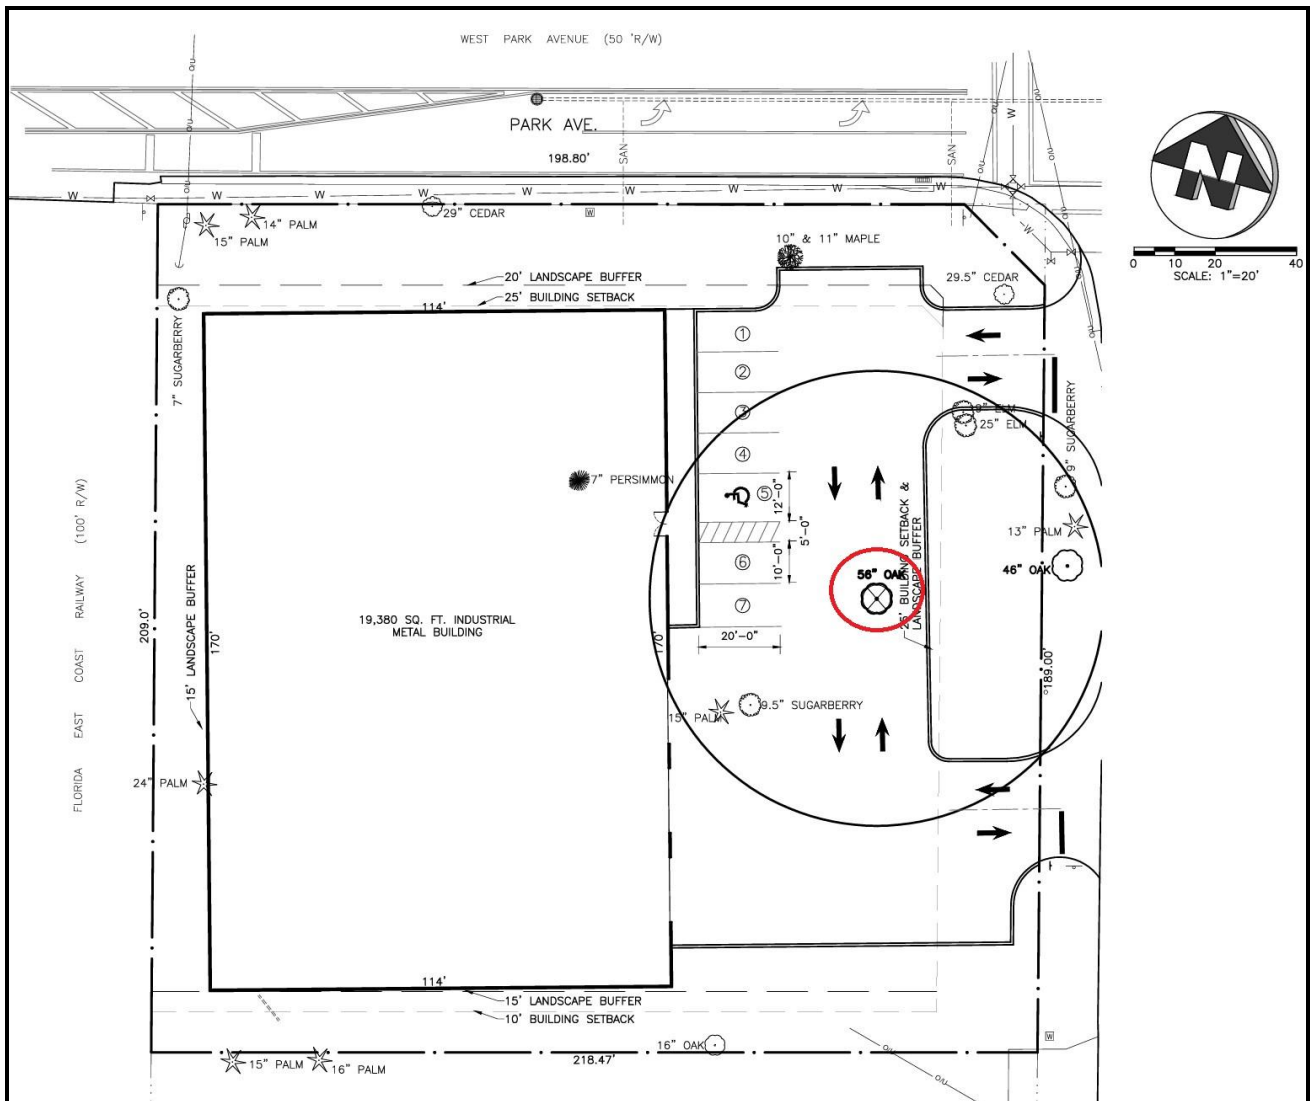
This tree is approximately 65' tall with a DBH of 56" and a LCR of around 50%. This tree grows in the center of the lot. The tree is healthy and vigorous with a spreading canopy. This tree is a Historic tree as defined by the City of Edgewater code:

This tree is centered in the middle of the project area, and the canopy extends into the area of proposed building.

This is a large tree with a spreading canopy and a large root plate. Based on the proposed site design, there is not a feasible way to conserve this tree on site and complete the project. The canopy would have to be reduced by more than 50% and impacts on the root system would be extensive. A large tree of this size has feeder root that expands well beyond the dripline of the tree. Cutting away lateral roots, grinding, and excavating beside this tree could cause it to be poorly anchored and unstable, increasing the overall risk rating.

The project seeks a variance from the city council to remove this tree to complete the project. The project offers to pay into the Tree Mitigation Fund and proposes planting new trees on site or elsewhere within the City of Edgewater such as **Whistle Stop Park** or **Rotary Park**. The Historic tree proposed for removal has a diameter of 56” and replacement trees offered will equal 56” or greater. For example, planting twelve (12) new live oak trees with diameters of 5” each on any city owned property or park.
