2903 TRAVELERS PALM
EDGEWATER, FL

*HISTORIC AND SPECIMEN
TREE HEALTH REPORT*

MARCH 2023

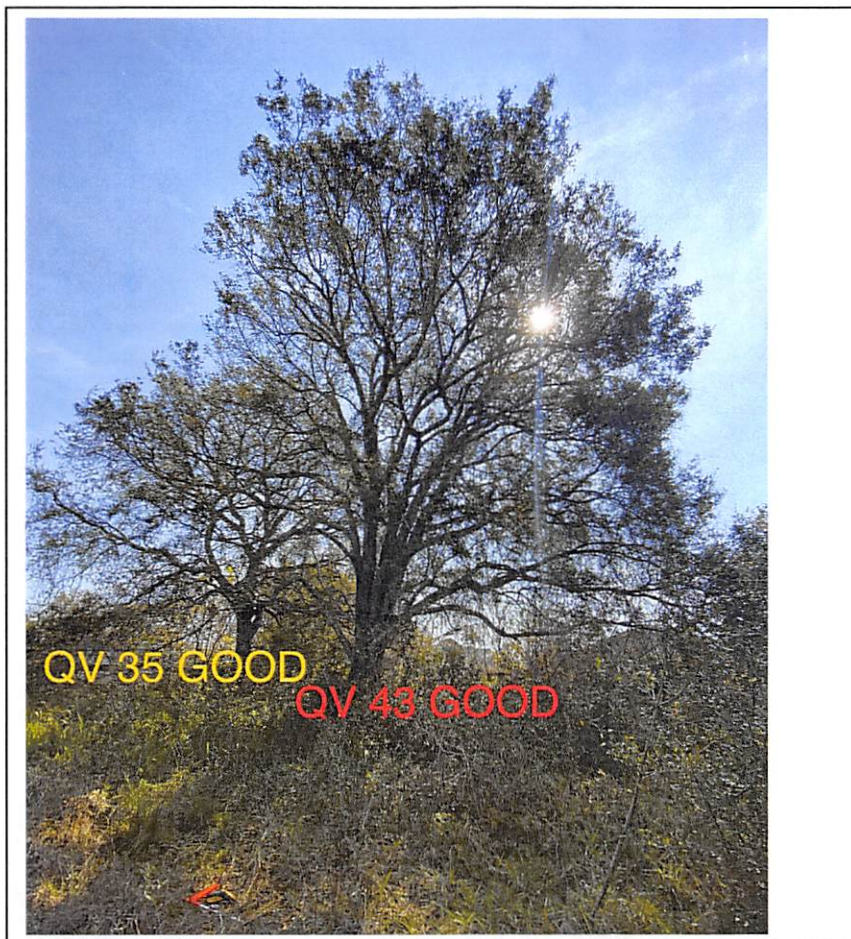
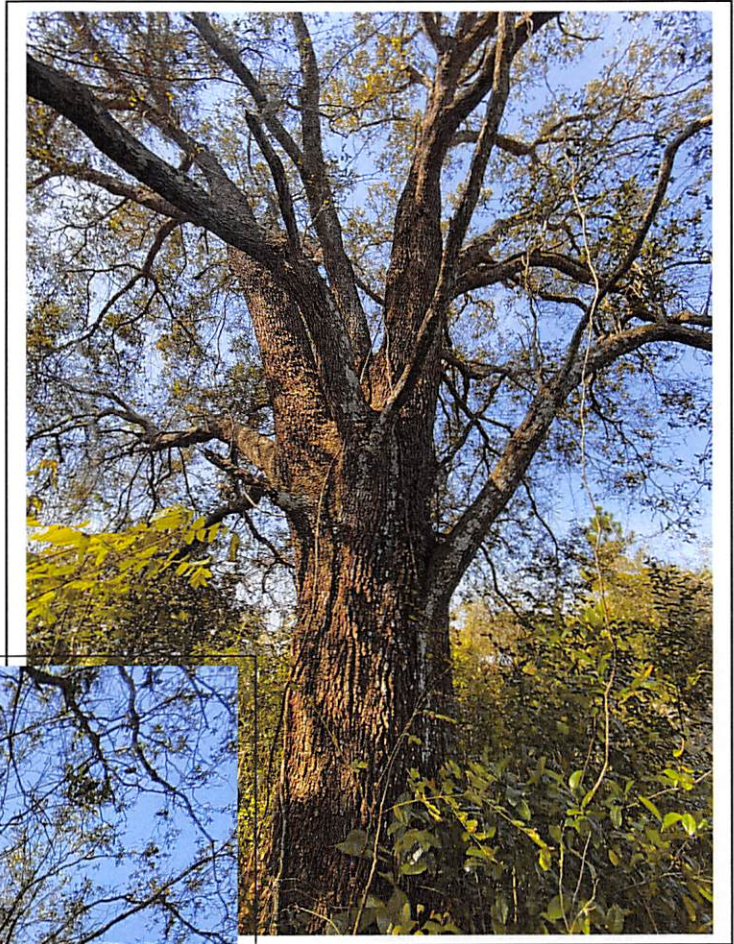
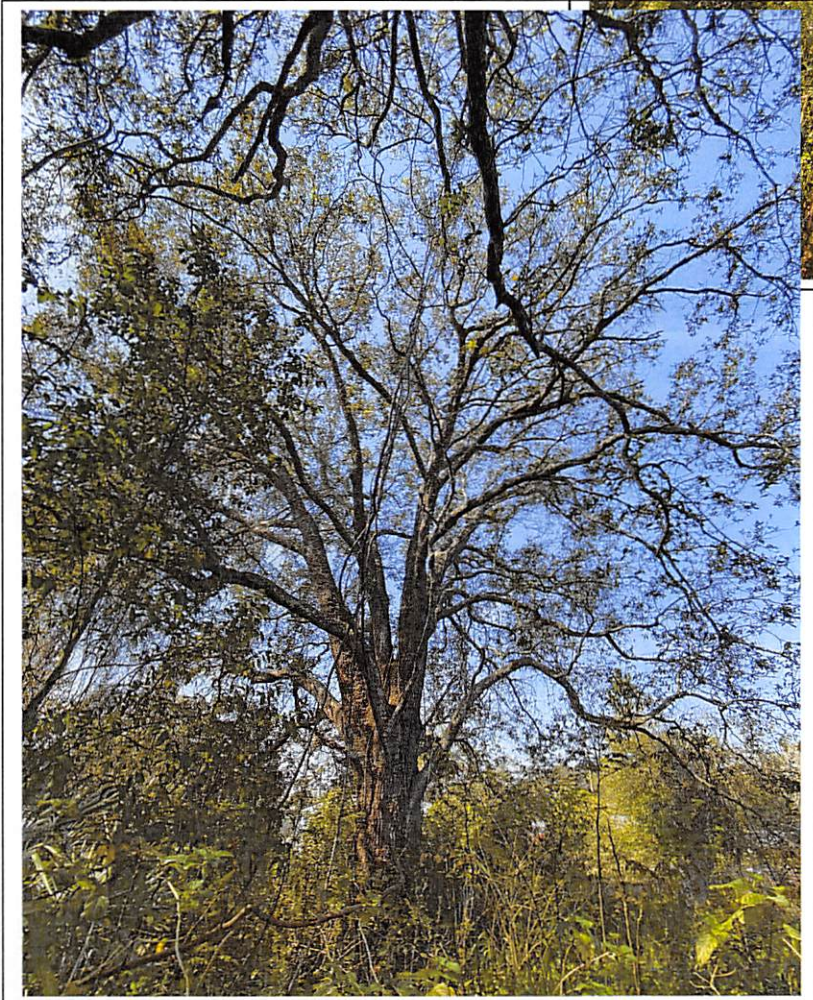
Historic Live oak 43”

Tree # 1: Historic Live oak 43"

Failure Potential/Defect Severity (F): 1

Consequence of Failure (C): 5

Total Risk Rating (F+C): LOW

- Tree is in good health with no visible defects, disease, or rot. It has excellent structure and full crown.
(This photo was taken in February when the trees are losing their previous years leaf growth and acquiring new, thus the crown is not completely filled out yet).
- This tree should be preserved if possible. It needs good pruning to remove the lower branches. Impacting the dripline severely to keep the tree would be better than removing the entire tree.

The historic live oak (43") that is located near the center of the lot is in excellent health with a beautiful structure. The likelihood of failure is low. It is recommended that this tree be preserved, even if the dripline must be severely impacted. This tree should be pruned by an ISA certified arborist prior to construction.

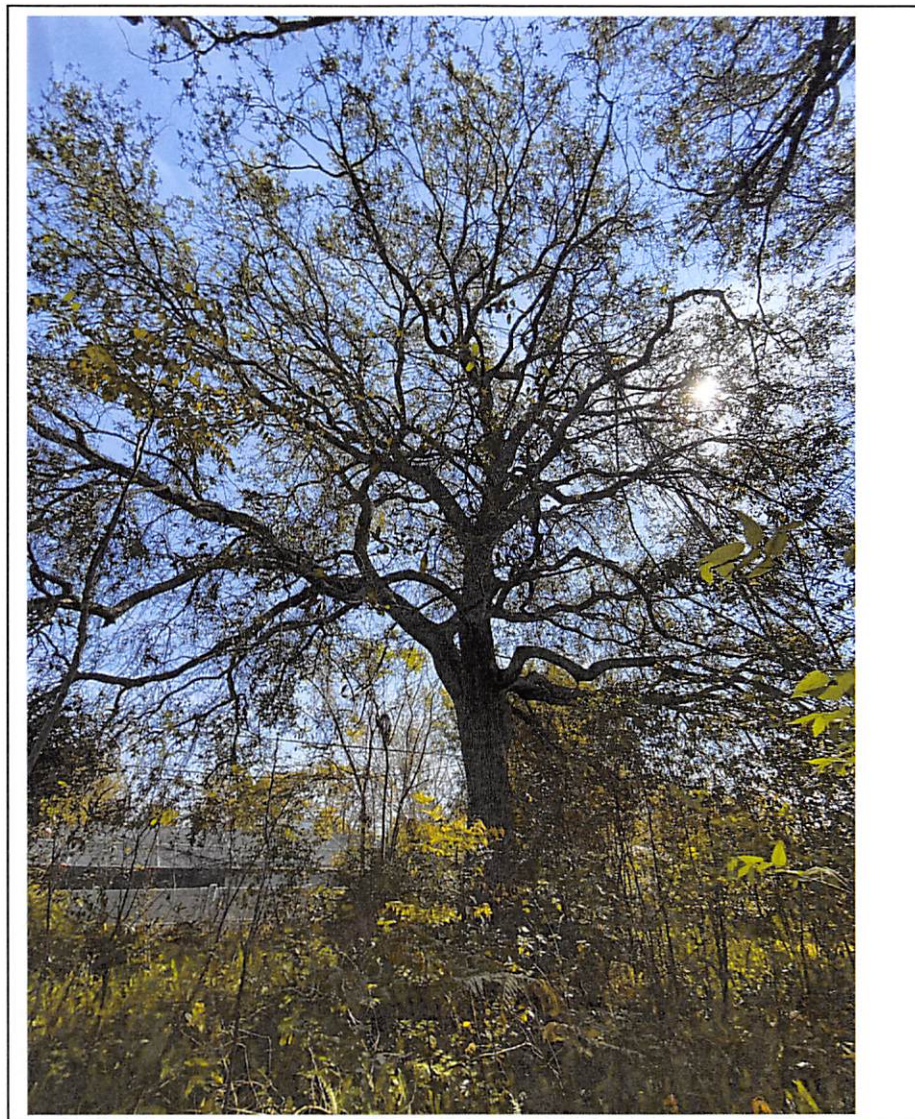
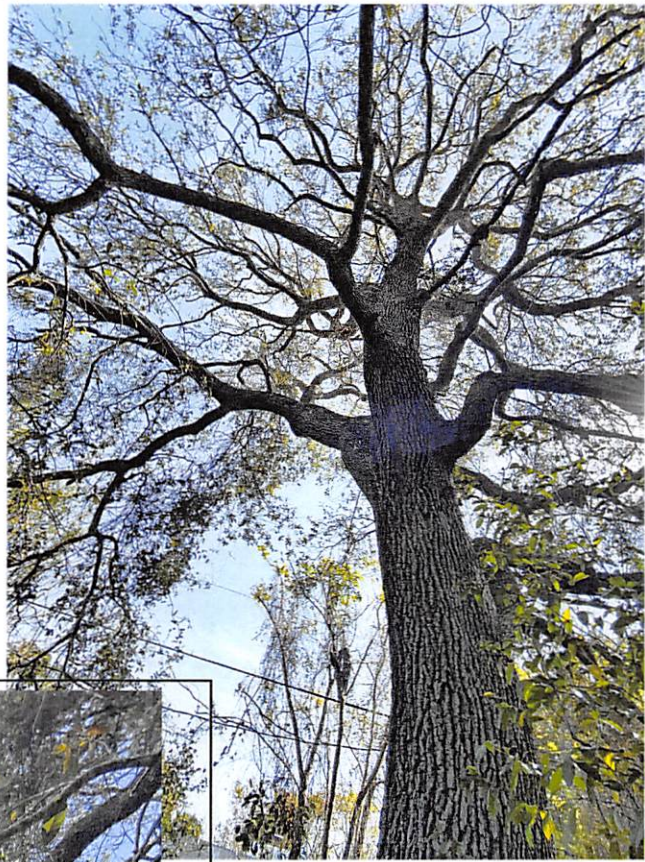
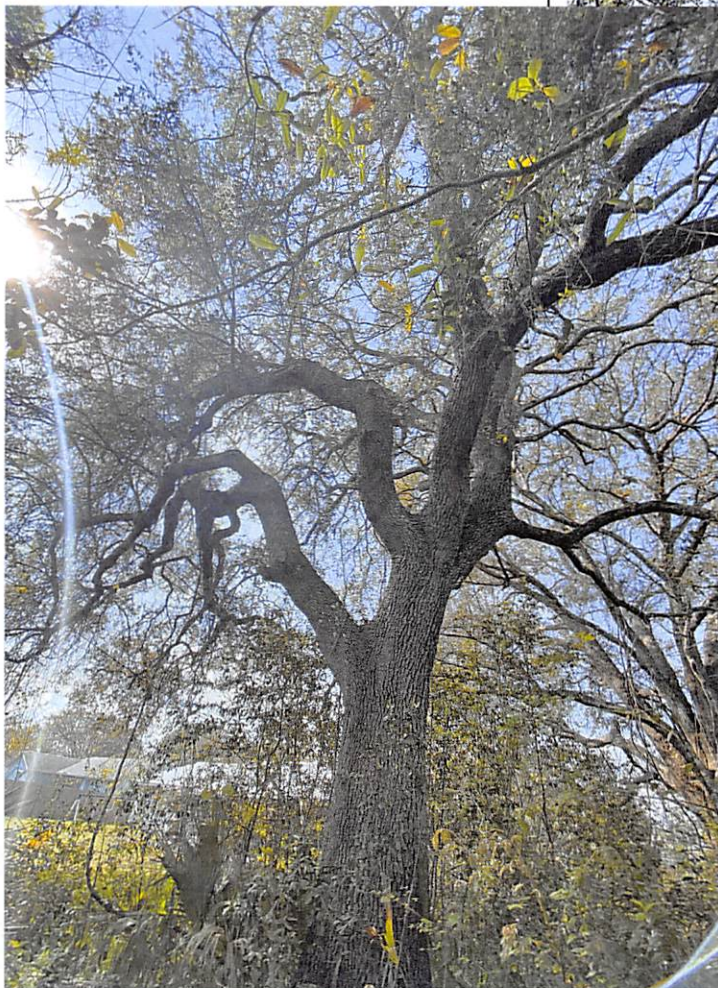
Tree # 2: Specimen Live oak 35" DBH

Failure Potential/Defect Severity (F): 1

Consequence of Failure (C): 5

Total Risk Rating (F+C): LOW

→ Tree is in good health with no visible defects, disease, or rot. The crown is slightly reduced, and there is a slight lean, however, this tree should be preserved if at all possible.

The specimen live oak (35") that is located near the southeast corner of the lot is very close to the historic size of 36". It is in good health with good structure and the likelihood of failure is low. It is recommended that the tree be preserved and pruned by an ISA certified arborist prior to commencement of construction.
