ARBOR SERVICES REPORT

Re: City of Edgewater – Historic Tree Assessment
2032 Juniper Drive

Project No. : ZC 15205

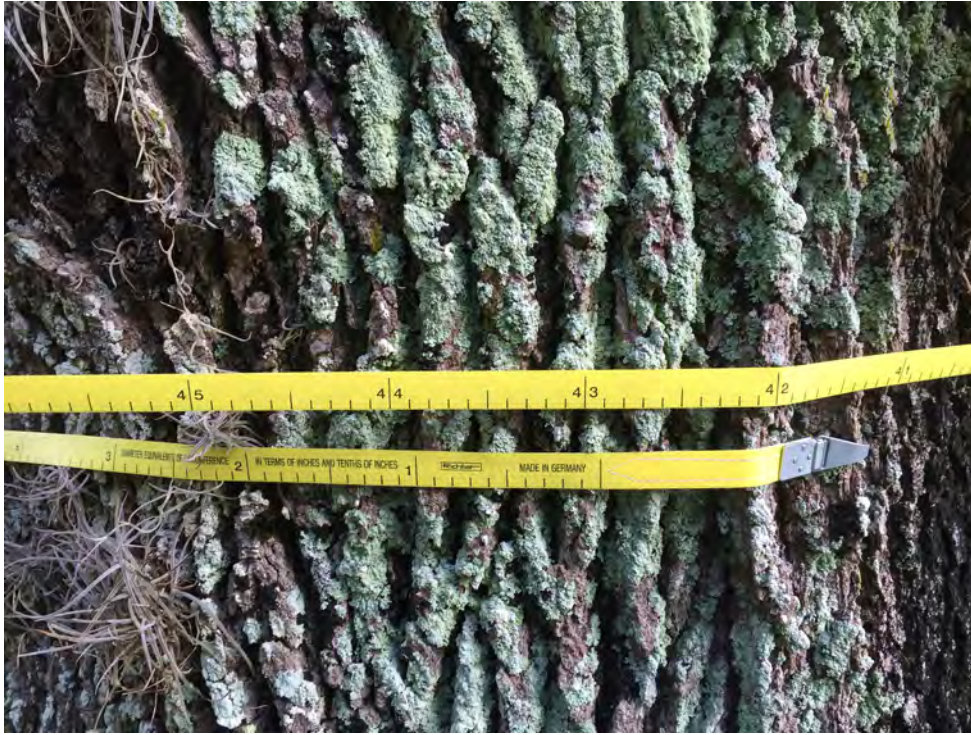
The property was visited on Wednesday, November 4, 2015. **The subject tree was confirmed to be a live oak (*Quercus virginiana*) with a DBH of 43" and therefore classified as a Historic Tree.** The identification was easily made as the tree exhibits characteristic live oak habits and morphology. The leaves are leathery in texture, dark green above and pale green/ grey tomentose below.

Figure 1 : Circumference of tree = 43" DBH

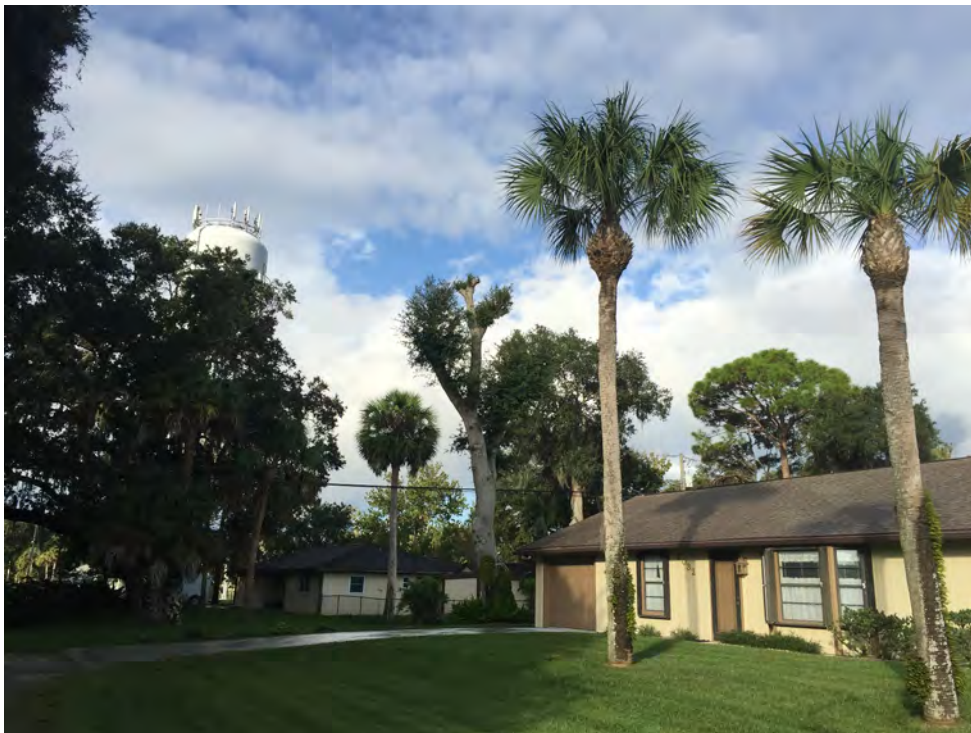
The subject tree is located near the dwelling and the driveway. The tree been severely trimmed and only re-sprouts from the main trunk system remain. This excessive trimming will likely result in poor health and a slow, but ultimate failure of the tree. At some time in the past, a large co-leader trunk facing the house was trimmed. That trimming was conducted properly and healed appropriately.

Figure 2 : Trunk of subject tree showing severe trimming

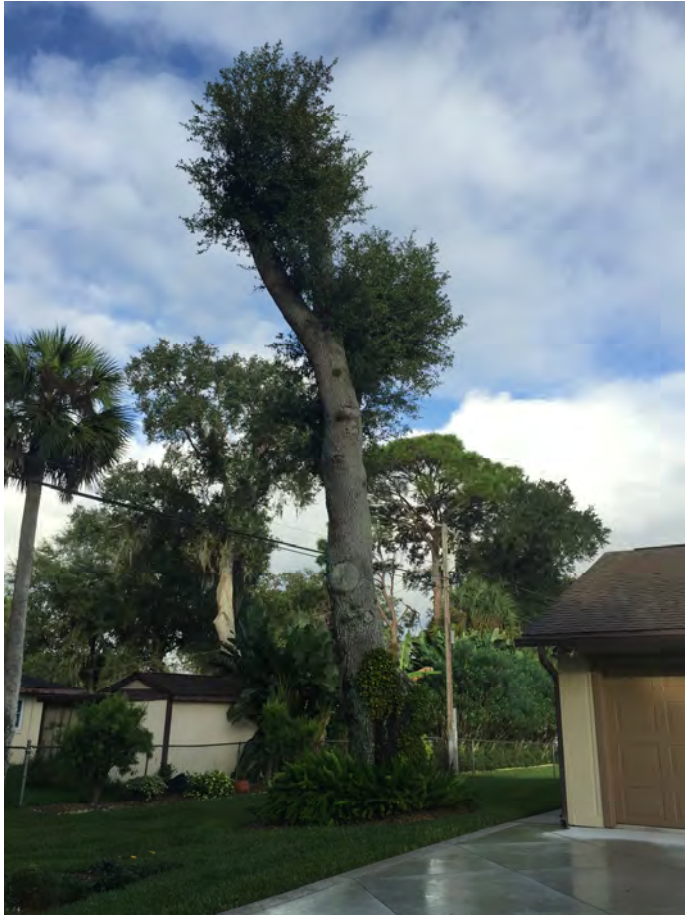
The tree has been severely trimmed and only the main trunk leader and re-sprouts remain.

Figure 3 : Trunk of subject tree showing severe trimming and re-sprouts

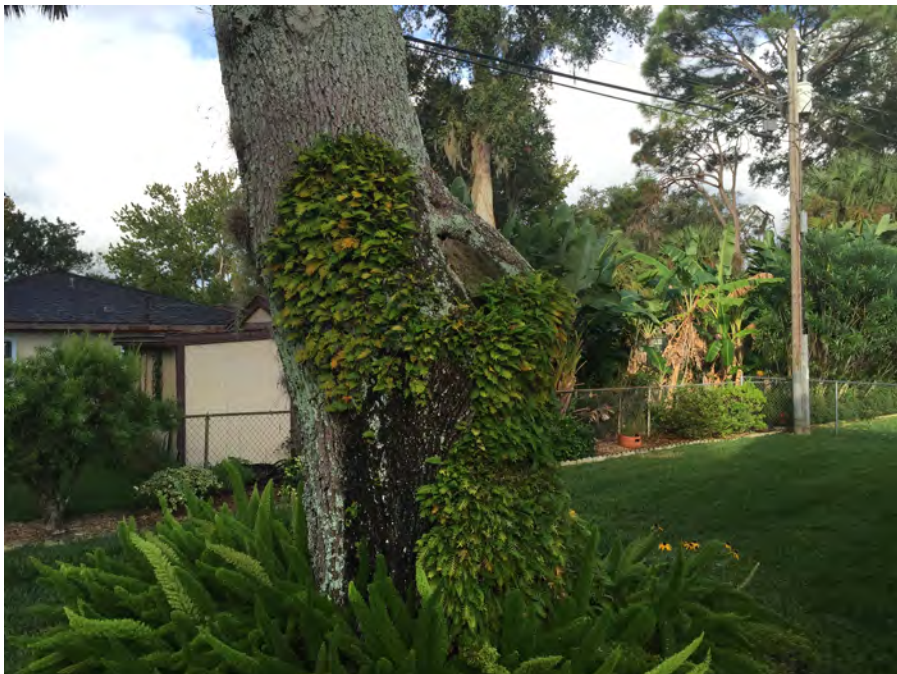
Figure 4 : Trunk of subject tree showing previously trimmed co-dominant trunk
