**Arbor Report**  
March 24, 2026

Re: Tree Health and Risk Assessment and mitigation for one (1) live oak (*Quercus virginiana*).

Services were retained to assess the health and risk for one (1) tree located at the **Merritts Boat & Engine Works** project, 200 W Park Avenue, Edgewater Fl., and propose mitigation options for removal. (Figure 1).

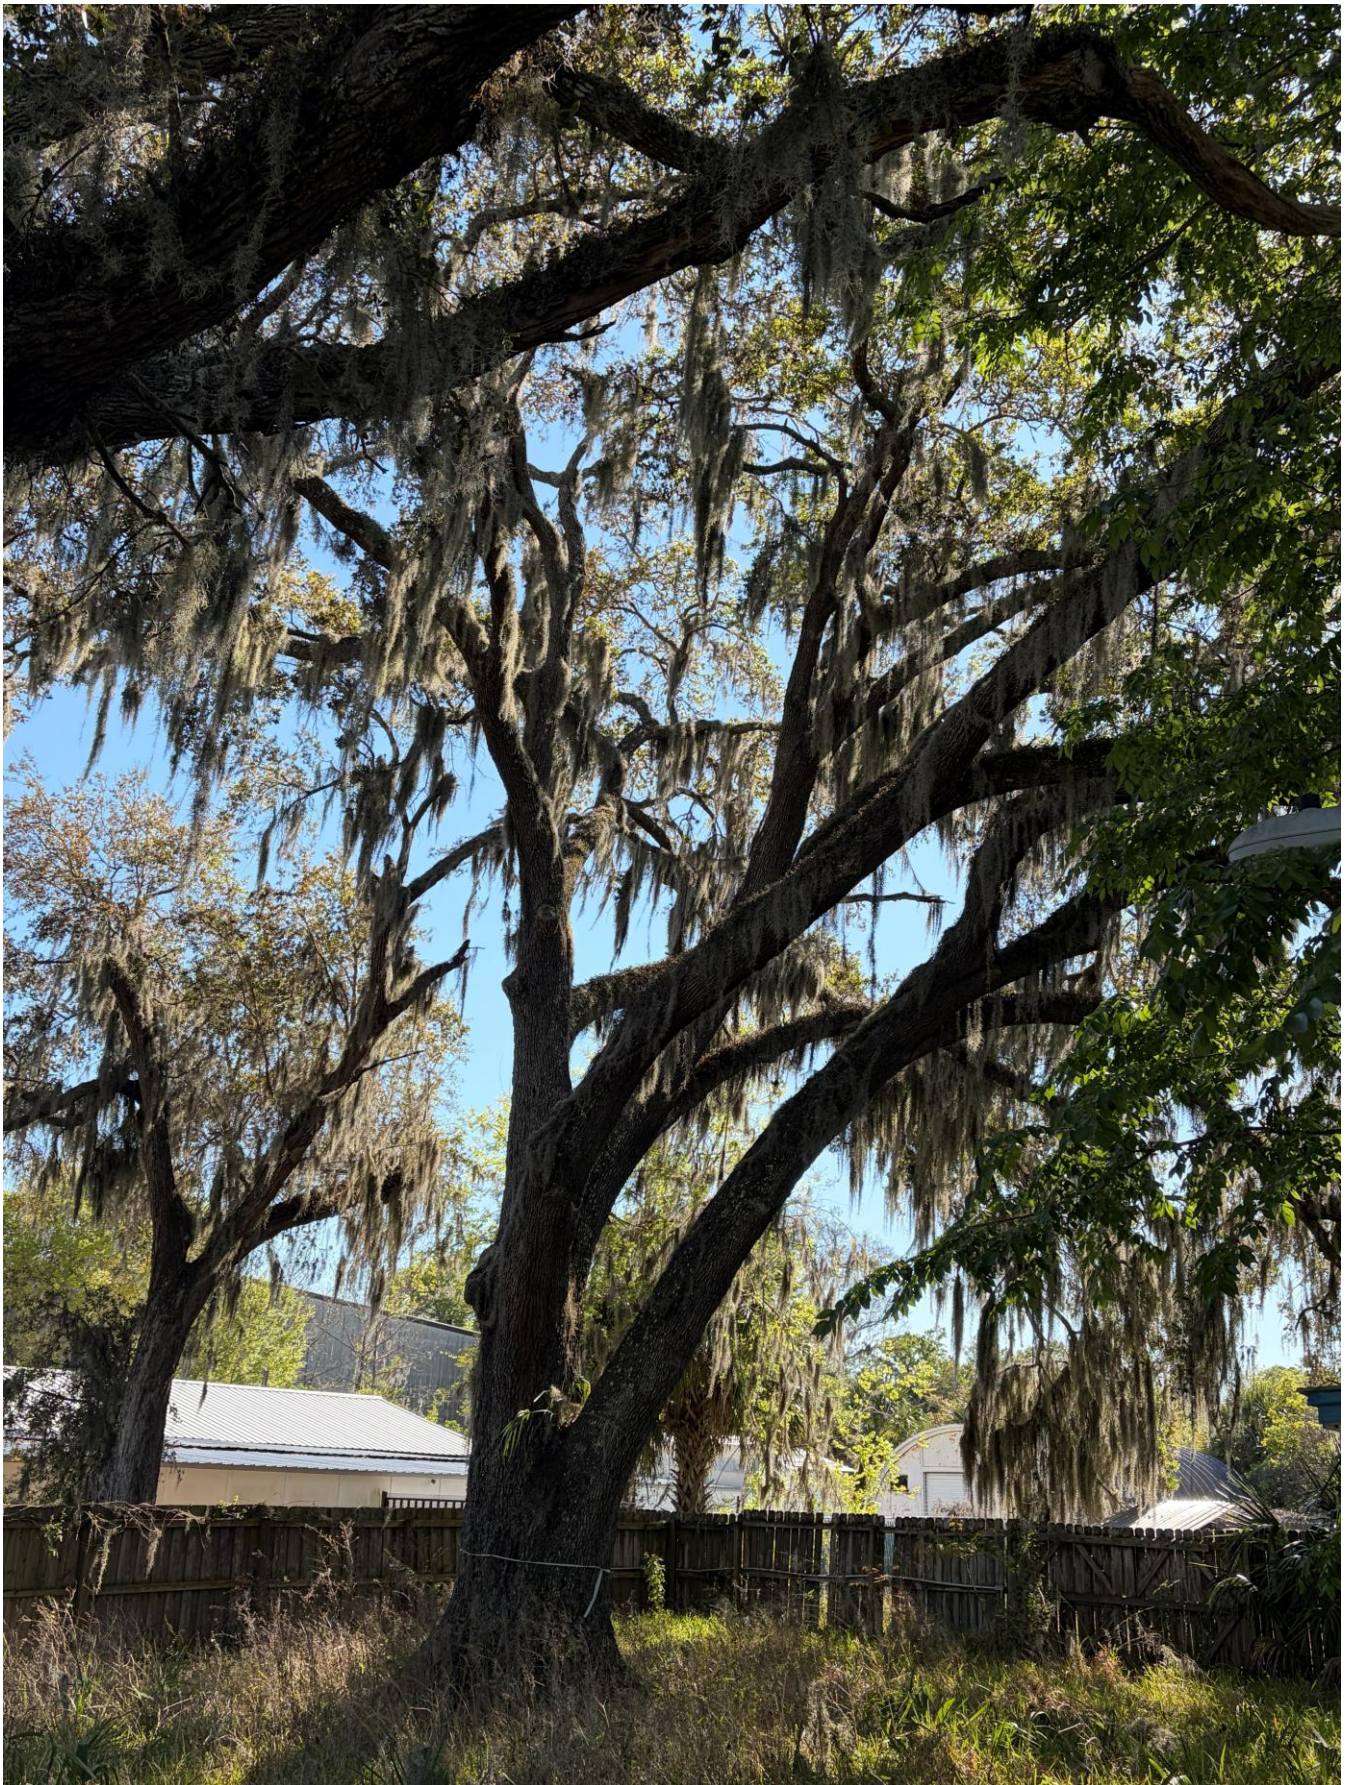
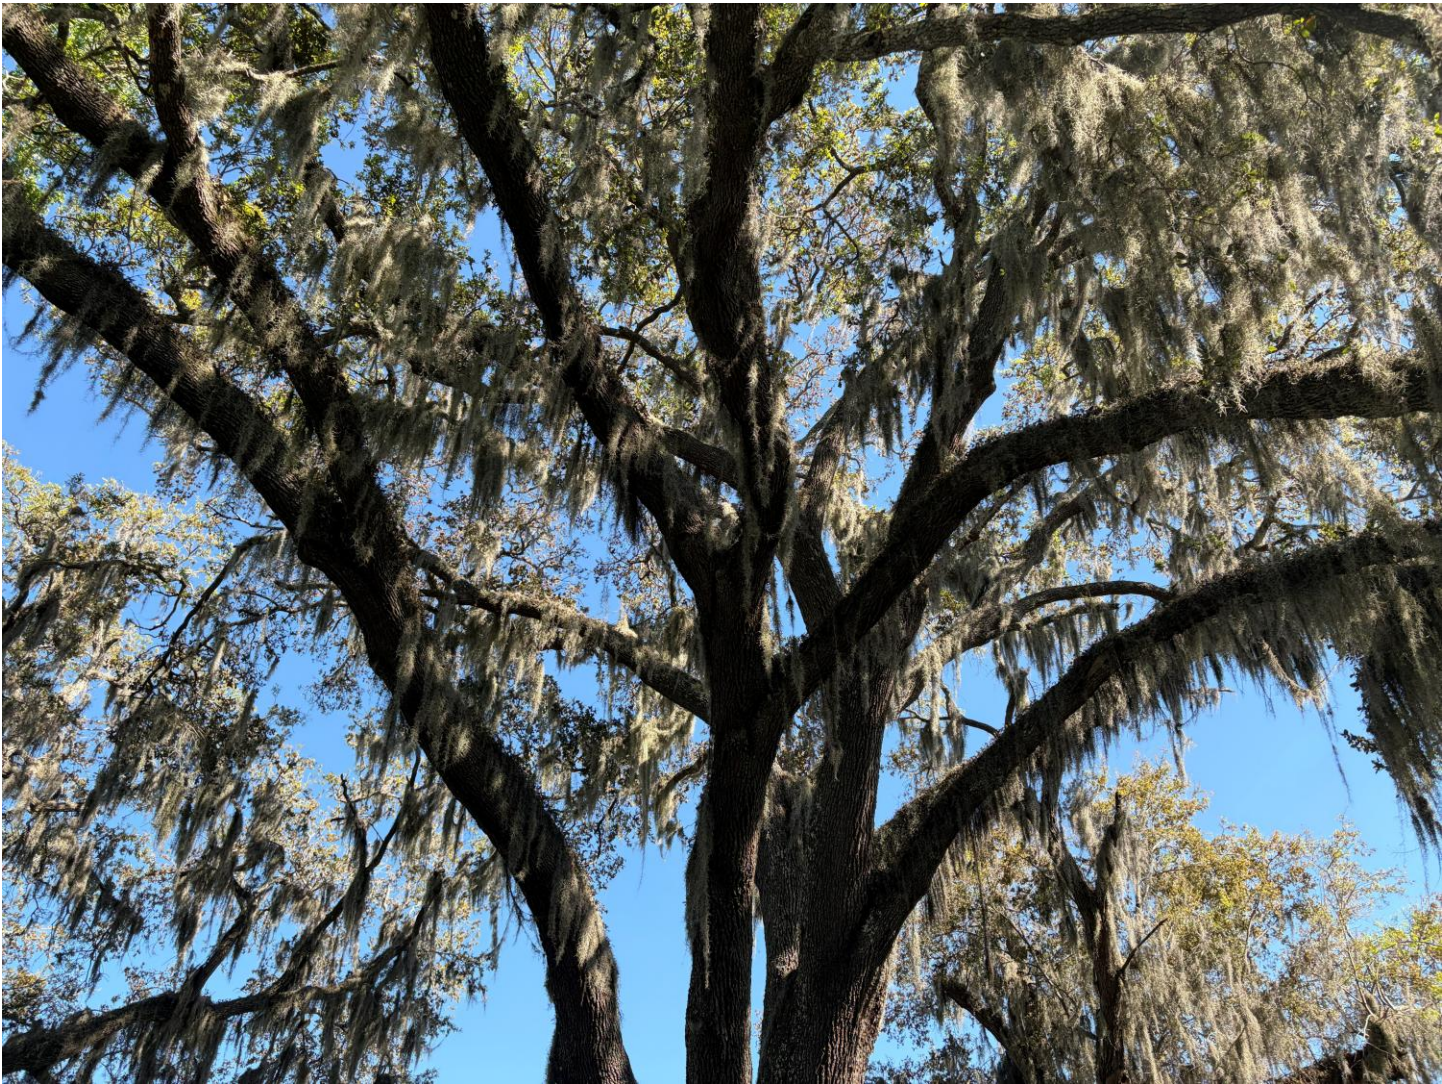
**Documentary Photographs:**

This tree is approximately 65' tall with a DBH of 56" and a LCR of around 50%. This tree grows in the center of the lot. The tree is healthy and vigorous with a spreading canopy. This tree is a Historic tree as defined by the City of Edgewater code:

This tree is centered in the middle of the project area, and the canopy extends into the area of proposed building.

This is a large tree with a spreading canopy and a large root plate. Based on the proposed site design, there is not a feasible way to conserve this tree on site and complete the project. The canopy would have to be reduced by more than 50% and impacts on the root system would be extensive. A large tree of this size has feeder root that expands well beyond the dripline of the tree. Cutting away lateral roots, grinding, and excavating beside this tree could cause it to be poorly anchored and unstable, increasing the overall risk rating.

The project seeks a variance from the city council to remove this tree to complete the project. The project offers to pay into the Tree Mitigation Fund and proposes planting new trees on site or elsewhere within the City of Edgewater such as **Whistle Stop Park** or **Rotary Park**. The Historic tree proposed for removal has a diameter of 56” and replacement trees offered will equal 56” or greater. For example, planting twelve (12) new live oak trees with diameters of 5” each on any city owned property or park.
