- Review Draft
   Stormwater Master
   Plan Findings and
   Recommendations
- Public Comment and Questions

### **Primary Project Tasks**

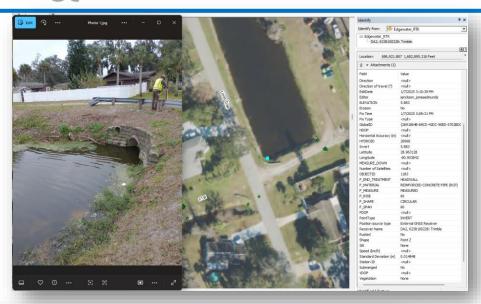
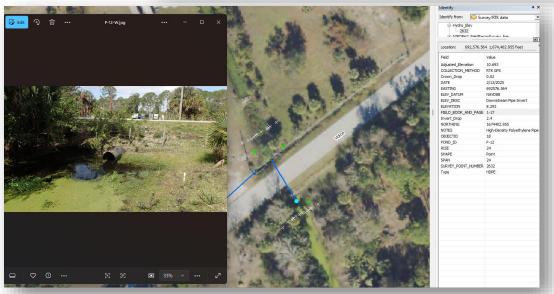
#### **Field Data Collection**

- Goal: Collect Data for Stormwater Model Development
- Collected Data at 1,135 Locations
  - Channel Cross-sections
  - Stormwater Collection Systems
  - Cross-Culverts
  - Pond Outfall Structures
- Data Collected Included
  - Invert Elevations
  - Size/shape
  - Material
  - Maintenance Condition
  - Photographs

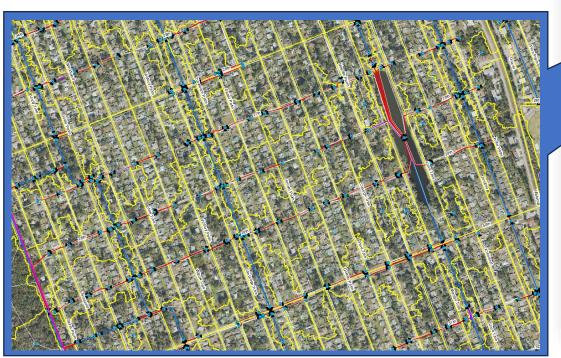
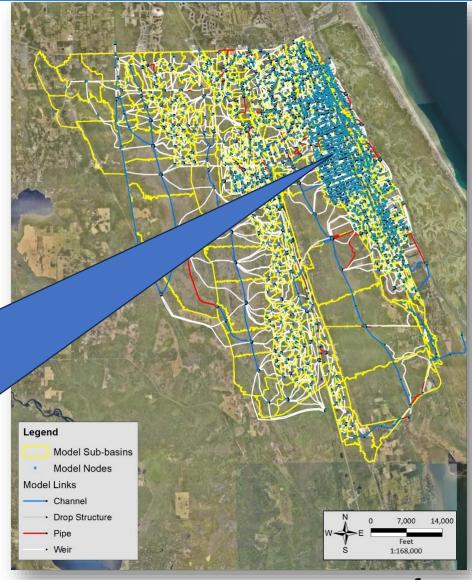
#### **Stormwater Model**

- Tool for:
  - Characterizing Existing Flooding
  - Testing and Developing Improvements
- Highly Detailed
- Extends Well Beyond the City's Limits

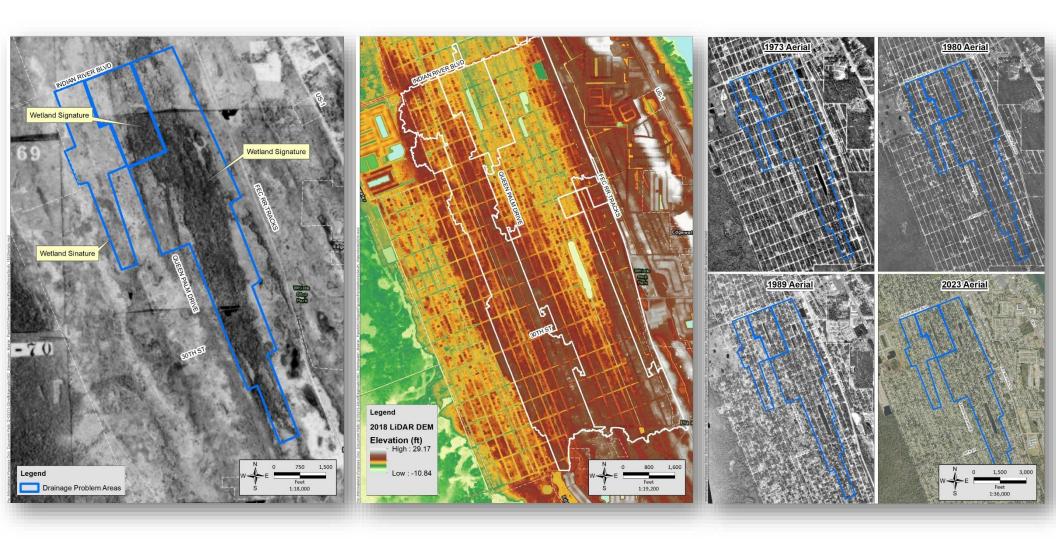
### **Florida Shores South**

Problem				Number	of Building w	ith Flooding	Above FFE
Area Id	Priority	Name	Location Description	2-Year/	10-Year/	25-Year/	100-Year/
Areara				24-Hour	24-Hour	24-Hour	24-Hour
1000	Tier 1	South Florida Shores: E10 Canal	South Florida Shores. E10 Canal basins between Indian River Boulevard (north), 22nd Street (south), Sabal Palm Drive (west), and Needle Palm Drive (east).	0	19	62	113
1009	Tier 1	South Florida Shores: E9 Canal	South Florida Shores. E9 Canal basins between Indian River Boulevard (north), 34th Street (south), Royal Palm Drive (west), and India Palm Drive (east).	0	3	74	254
1006	Tier 1	South Florida Shores: E13 Canal	South Florida Shores. E13 Canal basins between Indian River Boulevard (north), 26th Street (south), Willow Oak Drive (west), and Royal Palm Drive (east).	0	1	2	7
1022	Tier 2	E13 Canal between 27th Street and 34th Street	South Florida Shores. E13 Canal basins between 27th Street (north), 34th Street (south), Victory Palm Drive (west), and Travelers Palm Drive (east).	0	0	0	0

Total	0	23	138	374

Storm Event	Surface Flooding Volume				
Storiii Everit	(acre-feet)				
25-Year/24-Hour	228				
100-Year/24-Hour	403				
Equivalent to 100 acres

Model Nodes with 100-Year Peak Stage (ft-NAVD88) 100-Year/24-Hour Modeled Inundation Extents Subwatershed Boundaries

- Four recent storm events exceeding the 25–50-year return period storm.
- Florida Shores was developed in the 50's and 60's prior to modern stormwater regulations and design standards.
- Limited stormwater pond storage capacity Typically, 15-20% of newly developed area is reserved for stormwater ponds. Florida Shores South is ~1,300 acres, which would need 195-260 acres of ponds. Currently, there are ~36 acres of stormwater pond in Florida Shores South.
- Limited hydraulic capacity The drainage canals and pipes were originally intended to drain wetlands and provide mosquito control, not designed to handle 100-year flooding.
- Topographic challenges Worst flooding areas are in topographic low spots that were historically wetlands.
- Increasing impervious area as Florida Shores has experienced infill.
- Loss of surface storage as Florida Shores has experienced infill.

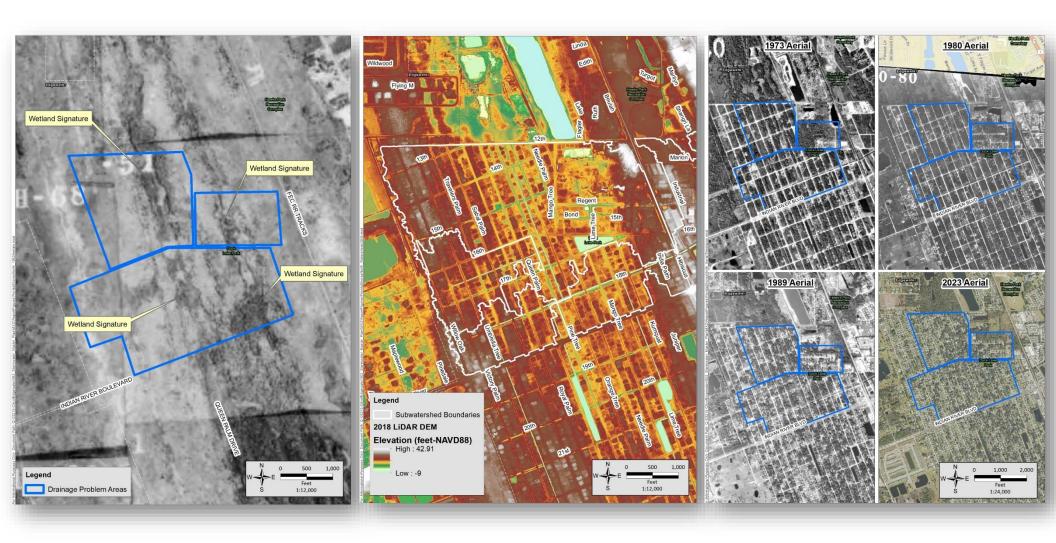
#### **Florida Shores North**

Problem				Number	of Building w	ith Flooding	Above FFE
Area Id	Priority	Name	Location Description	2-Year/	10-Year/	25-Year/	100-Year/
Alealu				24-Hour	24-Hour	24-Hour	24-Hour
1003	Tier 1	North Florida Shores: E11 Canal North of 16th Street	North Florida Shores. E11 Canal basins between 12th Street (north), 16th Street (south), Travelers Palm Drive (west), and Mango Tree Drive (east).	0	2	5	20
1010	Tier 1	North Florida Shores: Bond Street	Florida Shores North. Bond Street pond basins between Regent Street (north), 16th Street (south), Mango Tree Drive (west), and railroad tracks (east).	0	2	2	20
1013	Tier 1	North Florida Shores: E1, E11, and E12 Canals South of 16th Street	basins between 16th Street (north), Indian	0	0	0	16
			Total	0	4	7	56

Equivalent to 33 acres with 4-feet of water or ~65 Olympic Swimming Pools

- Four recent storm events exceeding the 25–50-year return period storm.
- Florida Shores was developed in the 50's and 60's prior to modern stormwater regulations and design standards.
- Limited stormwater pond storage capacity Typically, 15-20% of newly developed area is reserved for stormwater ponds. Florida Shores North is ~420 acres, which would need 63-84 acres of ponds. Currently, there are ~7 acres of stormwater pond in Florida Shores North.
- Limited hydraulic capacity The drainage canals and pipes were originally intended to drain wetlands and provide mosquito control, not designed to handle 100-year flooding.
- Topographic challenges Worst flooding areas are in topographic low spots that were historically wetlands.
- Increasing impervious area as Florida Shores has experienced infill.
- Loss of surface storage as Florida Shores has experienced infill.

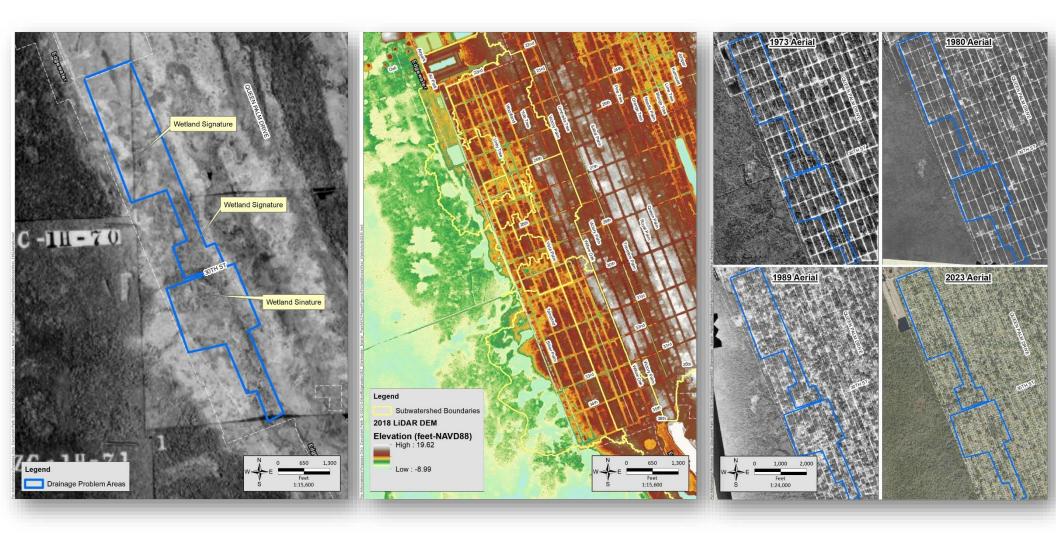
### **Florida Shores West**

Problem				Number o	Number of Building with Flooding Above FFE			
Area Id	Priority	Name	Location Description	2-Year/	10-Year/	25-Year/	100-Year/	
Alealu				24-Hour	24-Hour	24-Hour	24-Hour	
1019	Tier 2	South Florida Shores: T6 Canal South of 30th Street	South Florida Shores. T6 Canal basins between 30th Street (north), 36th Street (south), Silver Palm Drive (west), and Willow Oak Drive (east).	0	0	0	4	
1020	Tier 2	South Florida Shores: T1, T2, T3, T4, and T5 Canals	South Florida Shores. T1, T2, T3, T4, and T5 Canal basins between 22nd Street (north), 30th Street (south), Silver Palm Drive (west), and Woodland Drive (east).	0	0	0	2	
			Total	0	0	0	6

Equivalent to 18 acres with 4-feet of water or ~35 Olympic Swimming Pools

- Four recent storm events exceeding the 25–50-year return period storm.
- Florida Shores was developed in the 50's and 60's prior to modern stormwater regulations and design standards.
- Limited stormwater pond storage capacity Typically, 15-20% of newly developed area is reserved for stormwater ponds. Florida Shores West is ~510 acres, which would need 77-102 acres of ponds. Currently, there are ~6.5 acres of stormwater pond in Florida Shores West.
- Limited hydraulic capacity The drainage canals and pipes were originally intended to drain wetlands and provide mosquito control, not designed to handle 100-year flooding.
- Topographic challenges Worst flooding areas are in topographic low spots that were historically wetlands.
- Increasing impervious area as Florida Shores has experienced infill.
- Loss of surface storage as Florida Shores has experienced infill.

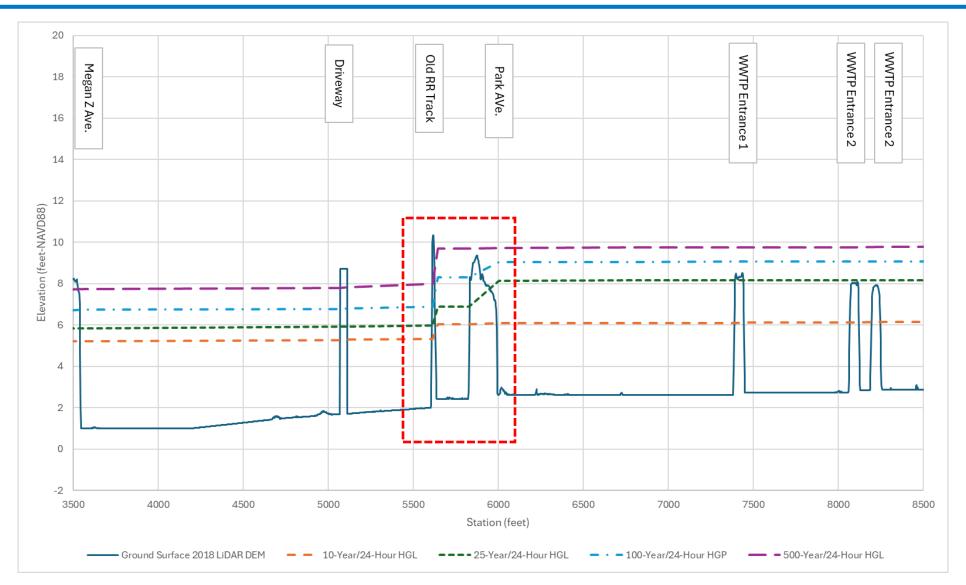
### **Edgewater Acres**

Problem				Number of Building with Flooding Above FFE				
	Area Id Priority Name	Name	Location Description	2-Year/	10-Year/	25-Year/	100-Year/	
Area Iu				24-Hour	24-Hour	24-Hour	24-Hour	
1004	Tier 1	Edgewater Acres East	Unnamed ditch basins between Park Avenue (north), Beulah Drive (south), railroad tracks (east), and Lake Avenue (west).	4	9	12	22	
1021	Tier 2	Edgewater Acres West	G5 Canal basins between Park Avenue (north), 12th Street (south), Mango Tree Drive (west), and Lake Avenue (east).	0	0	0	21	
			Total	4	9	12	43

- Four recent storm events exceeding the 25–50-year return period storm.
- Area was developed in the 50's and 60's prior to modern stormwater regulations and design standards.
- Limited hydraulic capacity The drainage canals and pipes were originally intended to drain wetlands and provide mosquito control, not designed to handle 100-year flooding. Undersized culverts at Park Avenue and old railroad track crossing.
- Topographic challenges Worst flooding areas are in topographic low spots that were historically wetlands.
- Significant offsite flow from south of 12<sup>th</sup> Street 730 cubic-feetper-second in the 100-year/24-hour event.

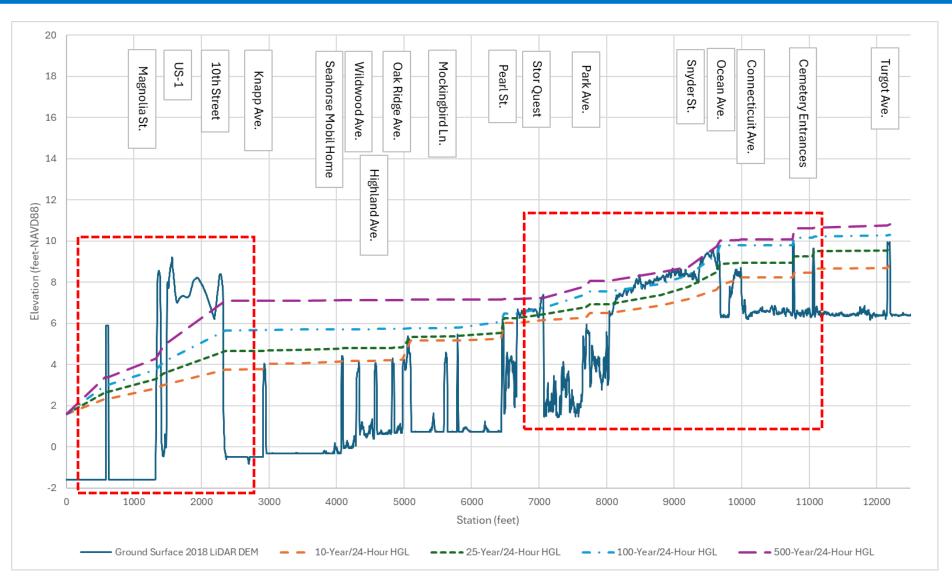
### **G2-G11 Canals**

Problem				Number o	Number of Building with Flooding Above FFE				
Area Id	Priority	Name	Location Description	2-Year/	10-Year/	25-Year/	100-Year/		
Alealu				24-Hour	24-Hour	24-Hour	24-Hour		
1001	Tier 1	G2 Canal North	G2 Canal basins between 10th Street (north), Park Avenue (south), railroad tracks (west), and US-1 (east).	1	9	23	67		
1002	Tier 1	G2 Canal South	G2 Canal basins between Park Avenue (north), Connecticut Avenue (south), railroad tracks (west), and US-1 (east)	0	6	10	29		
1015	Tier 2	Shangri La Village Subdivision	Shangri La Village Subdivision basin.	0	0	0	8		
			Total	1	15	33	104

- Four recent storm events exceeding the 25–50-year return period storm.
- Area was developed in the 50's and 60's prior to modern stormwater regulations and design standards.
- Limited hydraulic capacity The drainage canals and pipes were originally intended to drain wetlands and provide mosquito control, not designed to handle 100-year flooding.
- Topographic challenges Worst flooding areas are in topographic low spots that were historically wetlands.
- Increasing impervious area as the area has experienced infill.
- Loss of surface storage as the area has experienced infill.

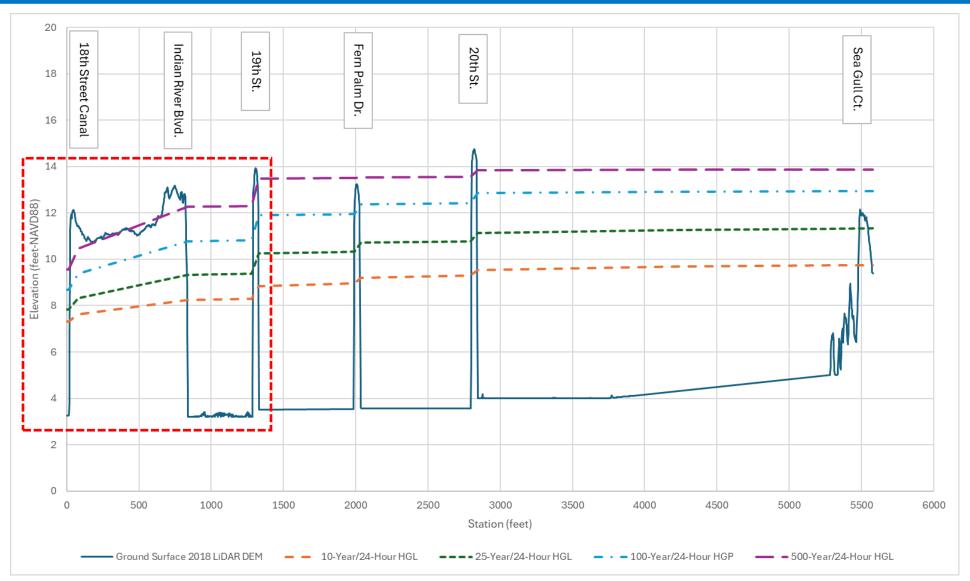
### **Pelican West**

Problem Area Id	Priority	Name	Location Description	Number of 2-Year/ 24-Hour	of Building w 10-Year/ 24-Hour	ith Flooding 25-Year/ 24-Hour	Above FFE 100-Year/ 24-Hour
1023	Tier 2	Pelican Cove Subdivision	Pelican Cove Subdivision basins that drain into the E5 Canal.	0	0	0	21
		Subulvision	Total	0	0	0	21

- Four recent storm events exceeding the 25–50-year return period storm.
- Area was developed prior to modern stormwater regulations and design standards.
- Limited hydraulic capacity The drainage canals and pipes were originally intended to drain wetlands and provide mosquito control, not designed to handle 100-year flooding.
- Topographic challenges Worst flooding areas are in topographic low spots that were historically wetlands.

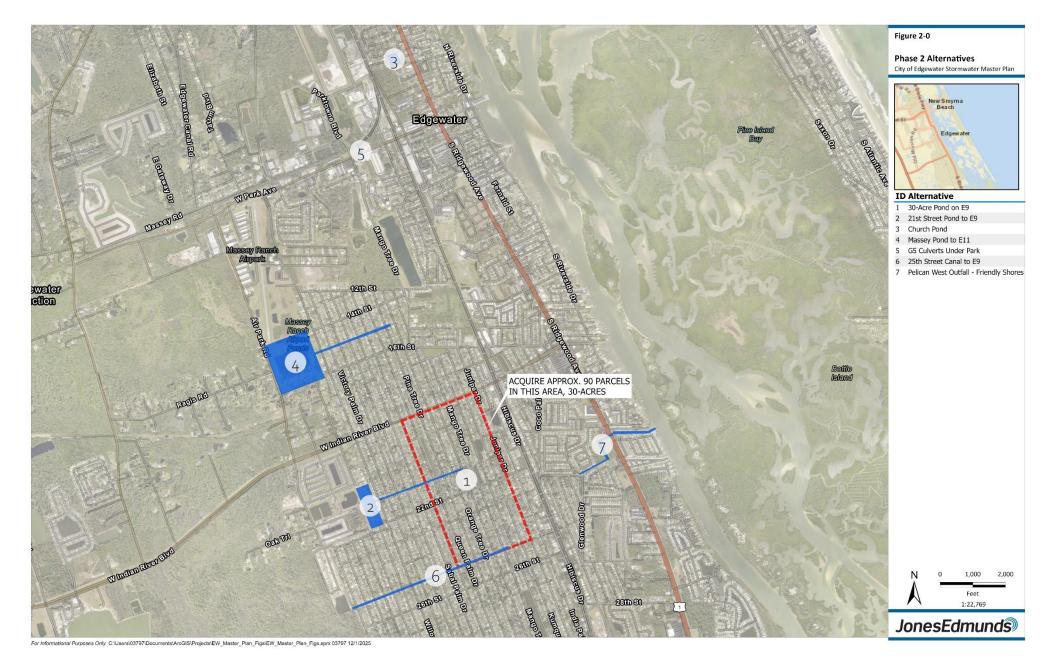
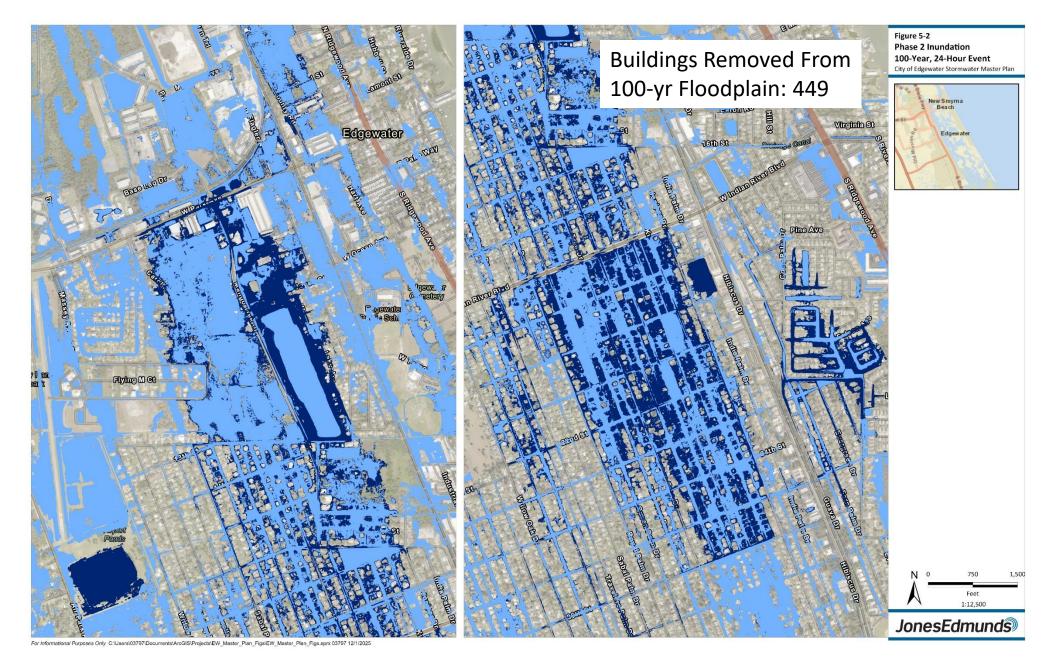
- Phase 2 project selection
  - Projects that require property acquisitions
  - Projects that require Phase 1 projects to avoid downstream impacts
  - Projects that will pose more permitting challenges
    - FDOT, FEC Railway, USACE
  - Projects that supplement projects from Phase 1
    - i.e. the E to W channels on 23rd, 25th, and 27th.
- Individual projects:
  - 30-Acre Pond (E9)
  - 21st Street Pond to E9
  - Church Pond
  - Massey Pond to E11 Channel
  - G5 Culverts Under Park Improvements
  - 25th Street Canal to E9
  - Friendly Shores Outfall To Pelican West Storage
  - Pelican West Storage

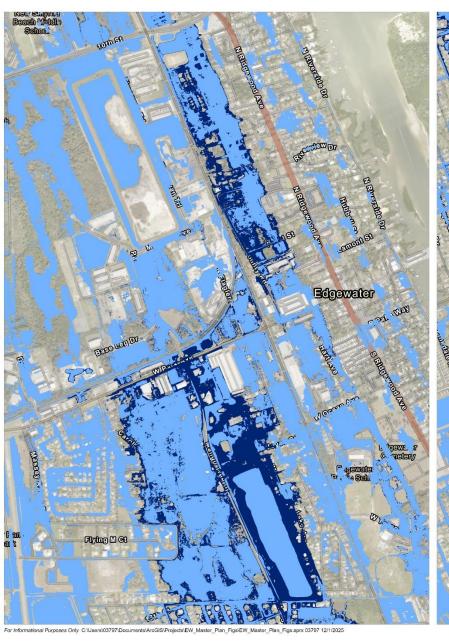
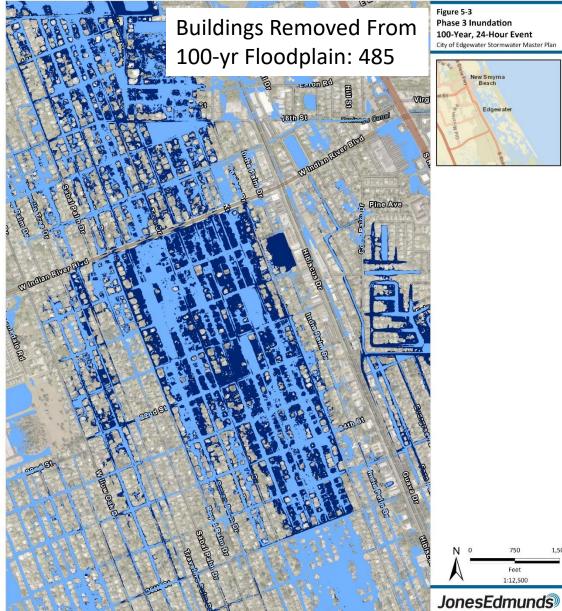
- Phase 3 project selection
  - Additional storage and conveyance improvements to supplement Phases 1 and 2
  - Projects that require Phases 1 and 2 projects to avoid downstream impacts
- Individual projects:
  - Box Culvert Indian River Blvd
  - Friendly Shores Outfall To E9
  - 15-acre Pond at Pearl
  - Mango Pond to E11 Channel
  - 23rd Street Channel to E9

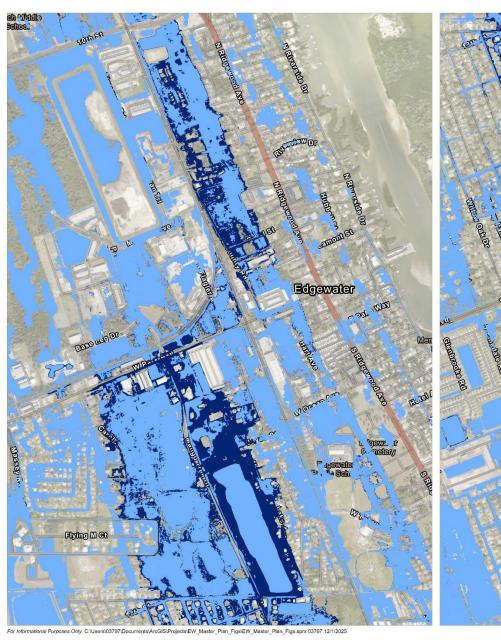
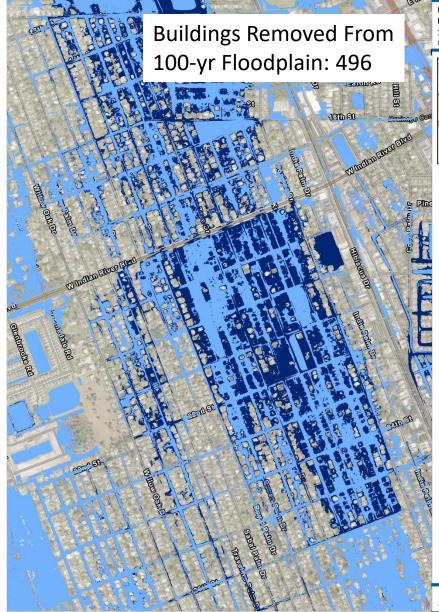
Figure 5-4
Phase 4 Inundation
100-Year, 24-Hour Event

- Phase 4 project selection
  - Projects that require large amount of property acquisitions in Florida Shores
  - Projects are intended to address flooding associated with predicted sea level rise
- Individual projects:
  - Florida Shores 100-Acre Pond
  - Pump Stations (Mango + Massey)
